2008 Annual Inspection and Radiological Survey Results for the Piqua, Ohio, Decommissioned Reactor Site

The former Piqua Nuclear Power Facility (PNPF), a decommissioned nuclear power demonstration facility, was inspected on April 24, 2008. The site, located on the east bank of the Great Miami River in Piqua, Ohio, is in good physical condition. There is no requirement for a follow-up inspection.

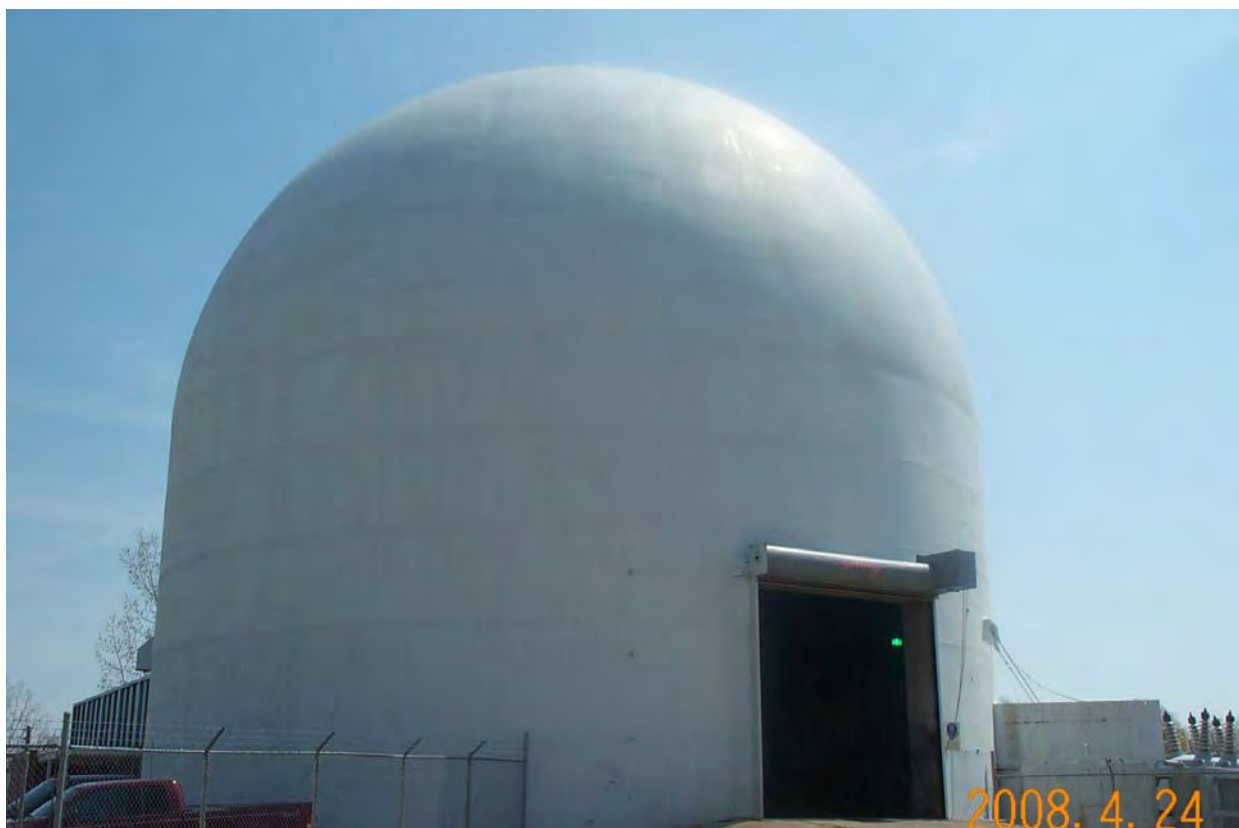
The Containment Building exterior was refurbished around 1995. The exterior of the reactor containment building is in good shape (PL-1). Rust stains are present on the northeast side of the containment building (PL-2). This area will be checked again next year to determine if the rust staining is increasing.

PIQ 4/2008. PL-1. Containment Dome.

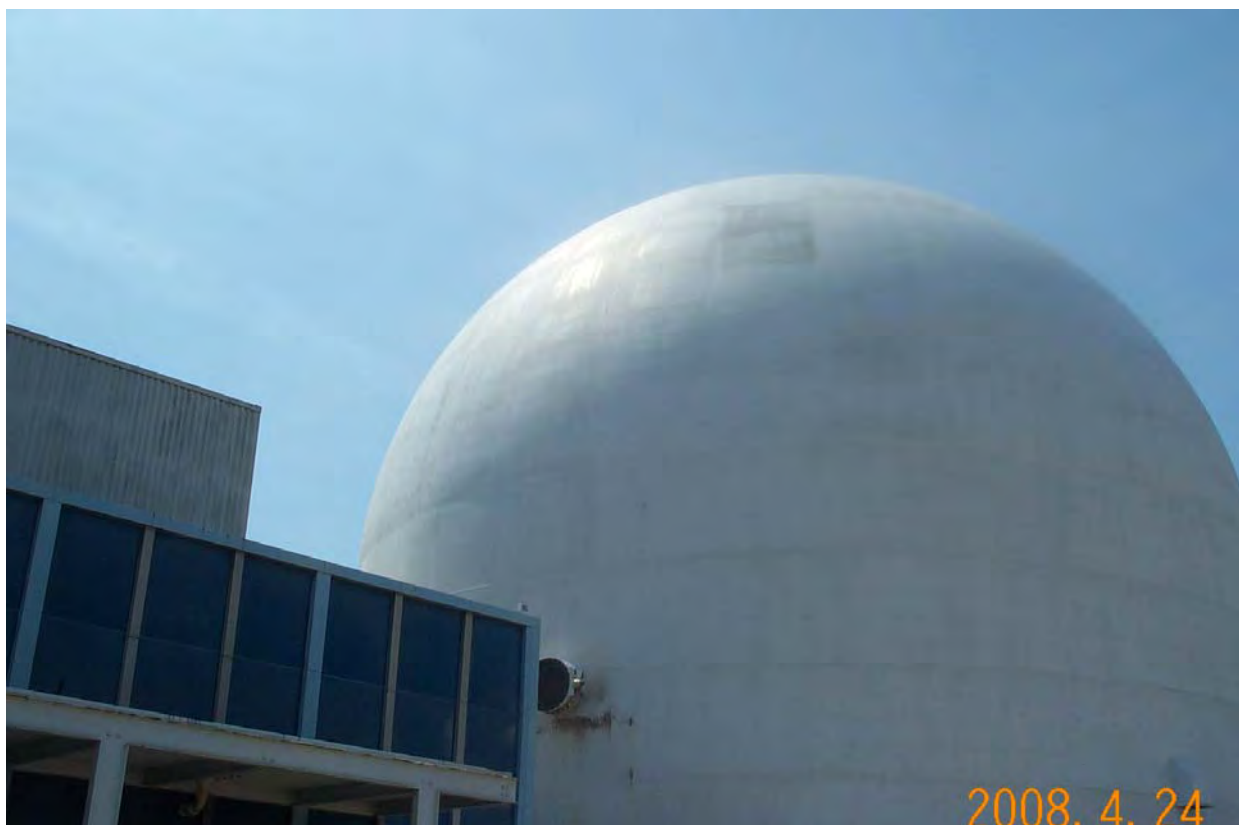
2. Rust staining is present on the exterior surface of the containment dome, next to the flat roof separating the containment dome from the office building (page 2).

PIQ 4/2008. PL-2. Containment Dome.

Recommendation: Check area again next year to determine if the rust stains are increasing.

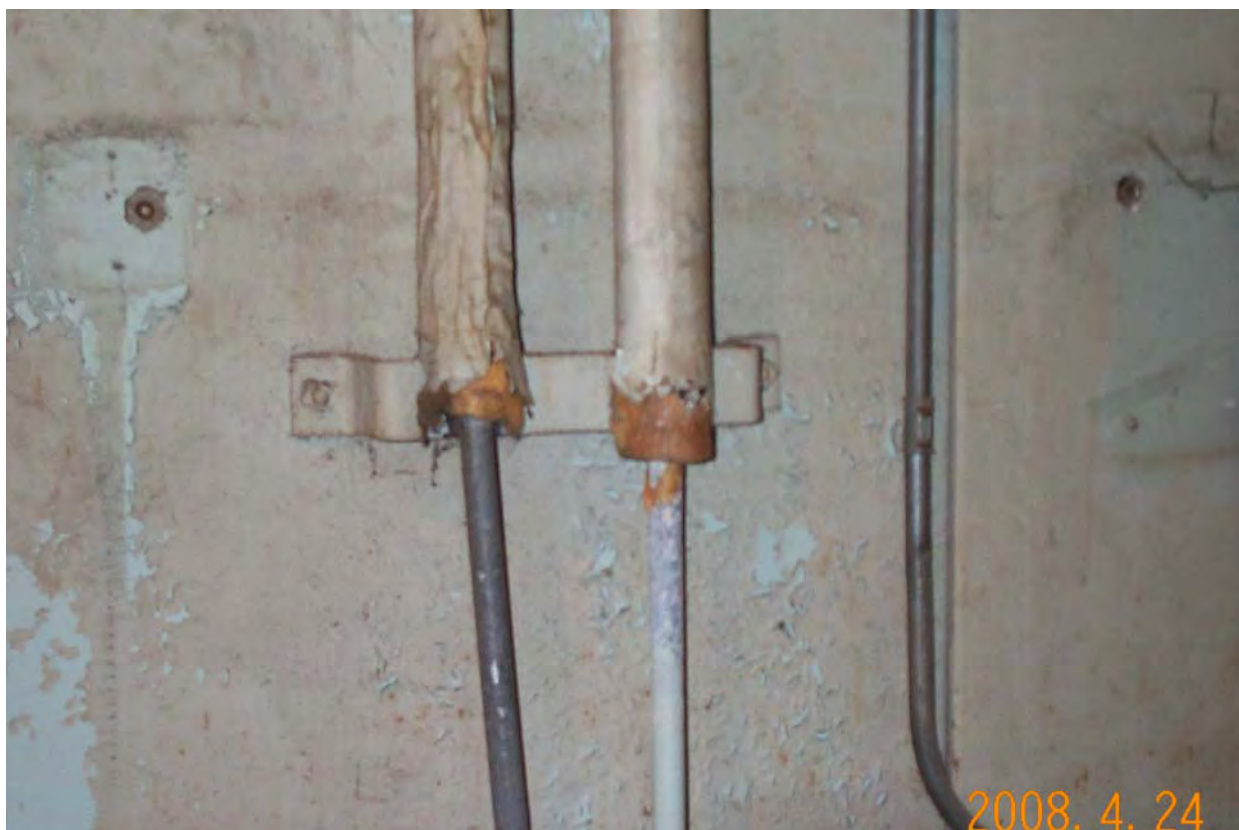
also peeling off the wall (PL-8). Pipe insulation on the 79-foot level exhibits some damage, but appears intact; friable asbestos is not evident (PL-9).

PIQ 4/2008. PL-9. Worn insulation, 79-foot level.

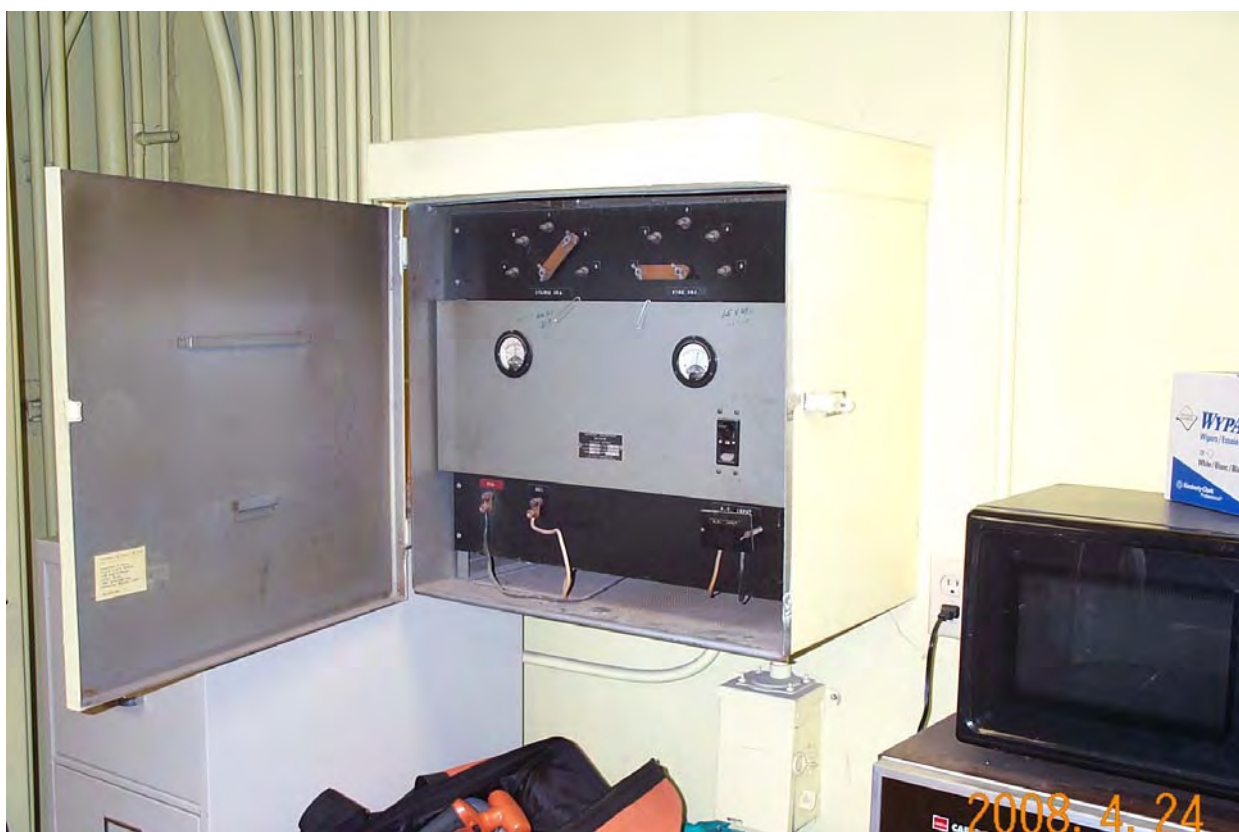
The system consists of 10 carbon (graphite) electrodes, buried radially approximately 10 to 20 feet from the building foundation, and a rectifier unit that provides DC current. The rectifier unit is mounted in the break room south of and outside the airlock on the 100-foot level (PL-10). Each carbon electrode is 3 inches in diameter and 60 inches long. The electrodes are connected to the rectifier unit by a header cable; splices are protected in flush-mounted boxes. A structure contact point for monitoring potential can be found on the shell associated with each electrode; some of the contact points also have cables remaining from an abandoned zinc anode protection system. The system also includes reference electrodes and test holes.

PIQ 4/2008. PL-10. Rectifier control panel, 100-foot level.

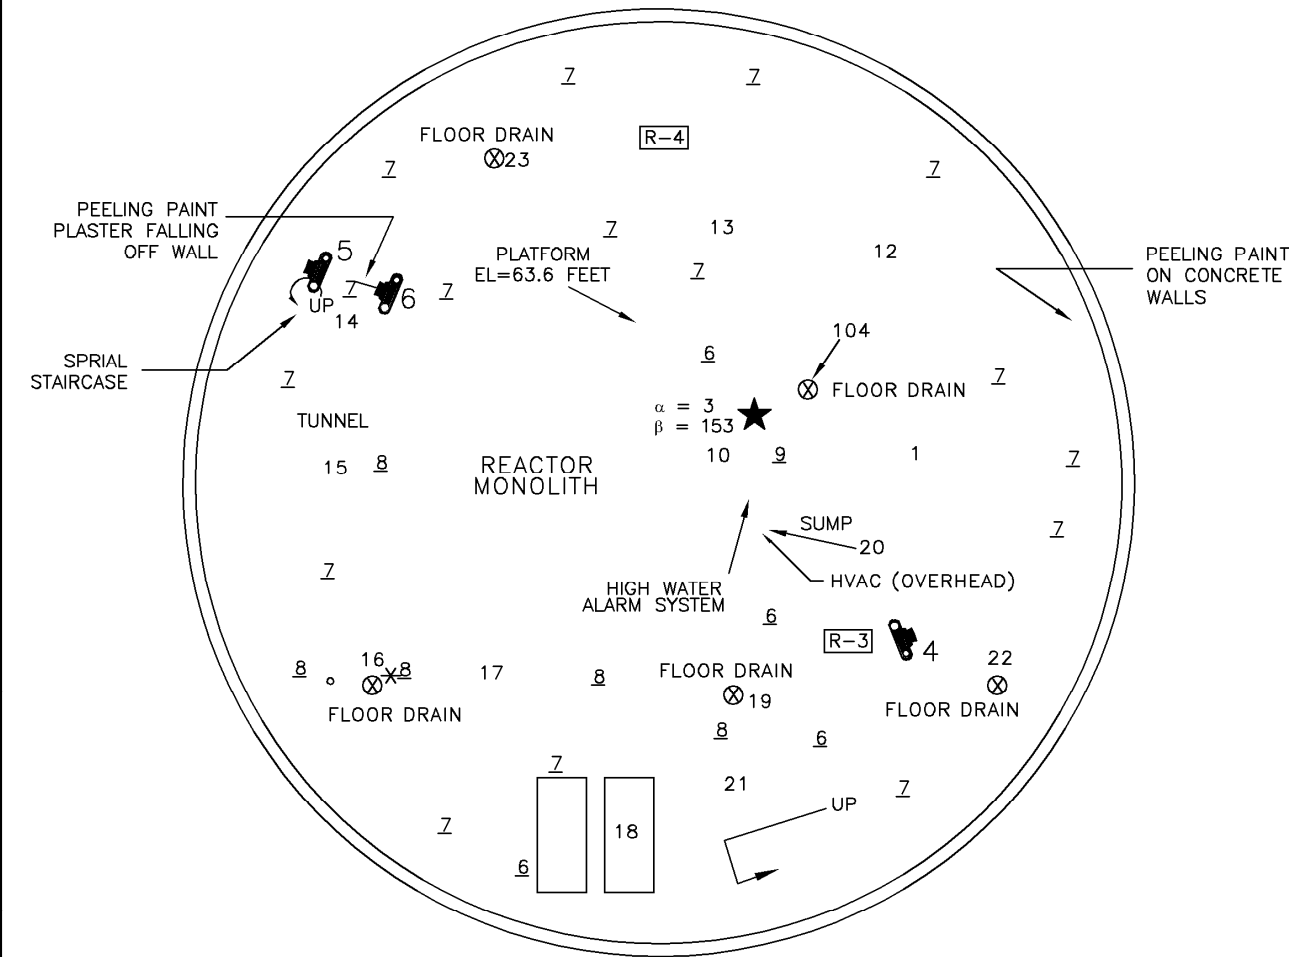
PLAN - 56 FOOT LEVEL

Table 2 presents direct surface and removable activity results. Direct surface measurement results indicate the floor drain at the lowest level of the containment building exhibited a direct beta activity of 3,825 disintegrations per minute per 100 square centimeters (dpm/100 cm²). The smear from this location indicated that no removable activity is present. This result is consistent with previous surveys. All other direct measurements were below the MDA.

NOTE: ALL 2008 GAMMA CONTACT AND
GENERAL AREA READINGS
WERE \leq BKGD ON THE 56-FOOT LEVEL.

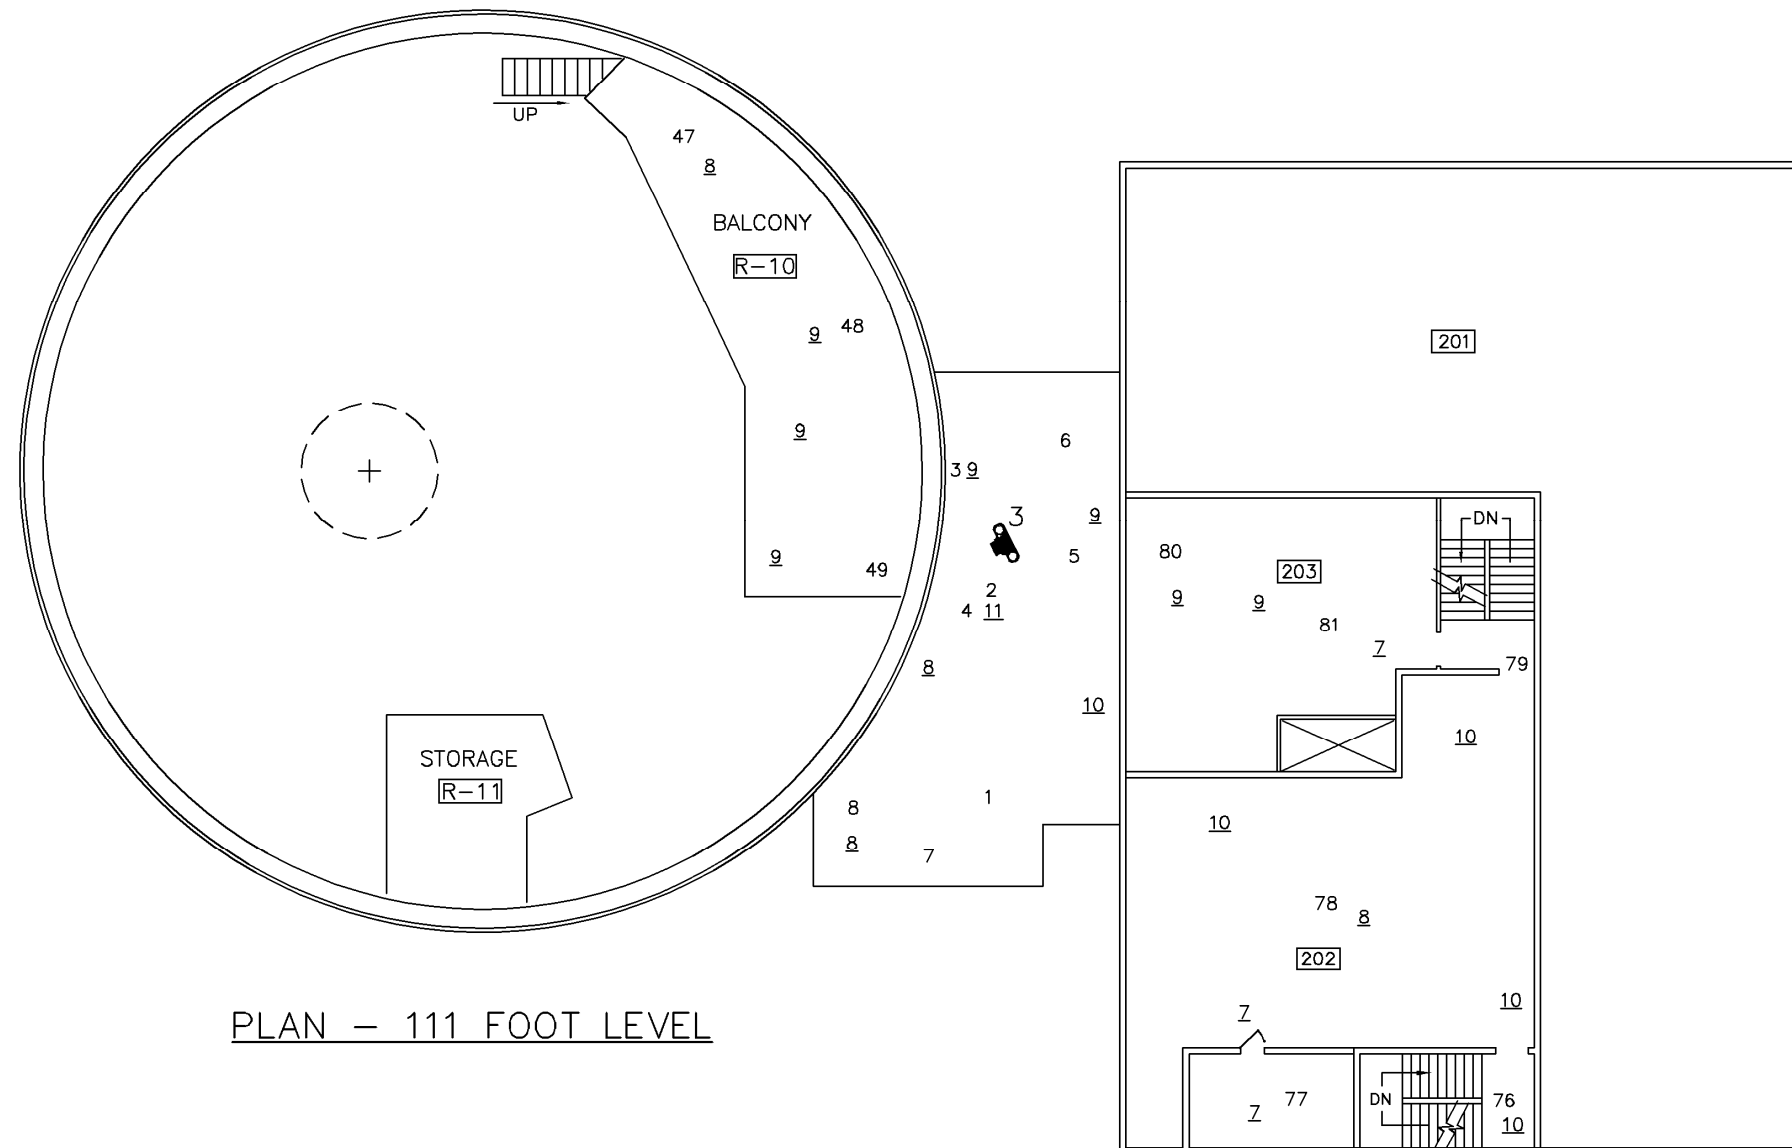
NOTE: SAMPLES 1-5 WERE DELETED
BECAUSE HVAC EQUIPMENT HAS BEEN
REMOVED FROM THE ROOF.

NOTE: ALL 2008 GAMMA CONTACT AND
GENERAL AREA READINGS
WERE \leq BKGD ON THE 111-FOOT LEVEL.
